LOC RWY 6  
MIFFLIN COUNTY (RVL)

MIFFLIN COUNTY (RVL)  
LOC RWY 6

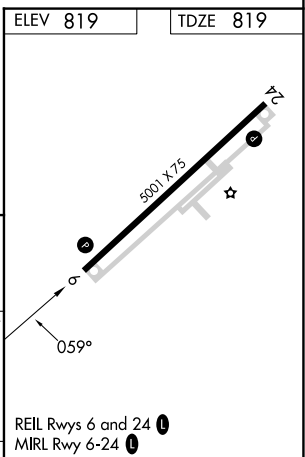
**MISSED APPROACH:** Climb to 3000 then climbing right turn to 4000 on heading 147° and RAV VORTAC R-290 to HERDA INT/RAV 30 DME and hold.
